PRODUCT RECALL NOTICE

SIP-DECT RFP Recall – MAC Address Issue

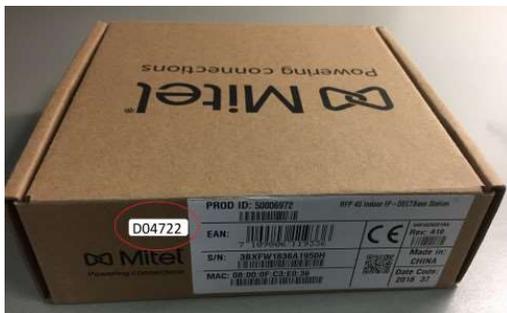
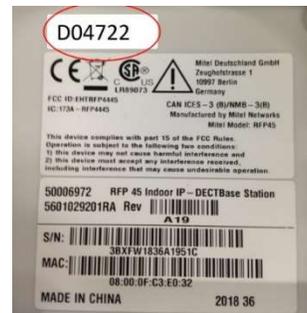
- OR any affected product manufactured prior to 2020 week 23 will be marked with a **D04722 sticker** on the outside carton box and product label. These are good units that have been reprogrammed.
